Manhole Inspection Summary

Manhole # S35W__065MH

Insp Date: 9/18/08 9:28 AM

Location Address: **61 e heath st**

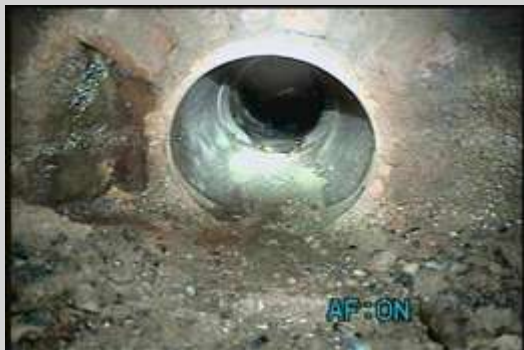
12 O'Clock Outflow

8 in. Circular Gravity Sewer
Pipe Out @ 12 O'Clock

Infiltration: **None** Pipe Seal Cond: **Unknown**
